Report No. FAA/RD/79-4, VOL-1 LONGITUDINAL JOINT SYSTEMS IN SLIP-FORMED RIGID PAVEMENTS, AD AO 6632 Volume 1, - Literature Survey and Field Inspection Ernest J./Barenberg Roger E./Smith COPY FILE Interim Report DOT-FH-11-8474 Document is available to the U.S. public through the National Technical Information Service, Springfield, Virginia 22161.

### **U.S. DEPARTMENT OF TRANSPORTATION**

FEDERAL AVIATION ADMINISTRATION

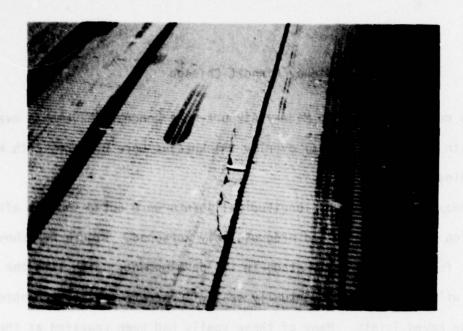
Figure A-8 - Initiation of Keyway Failure, Midway Airport

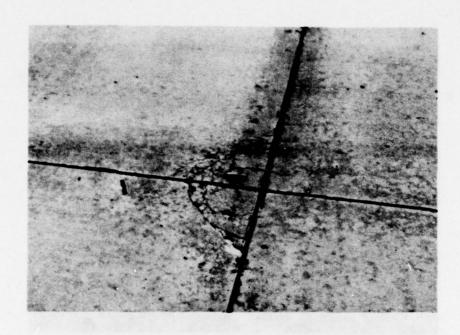
Figure A-13. Longitudinal Joint Distress Near a Transverse Joint, Stapleton Airport.

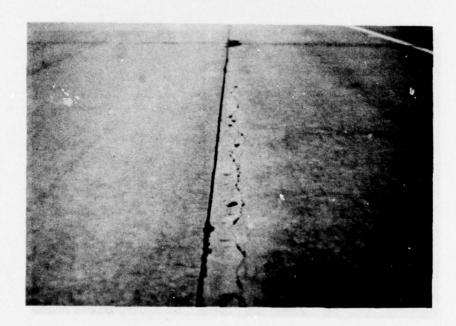
Deterioration of the concrete was a significant factor in the keyway distress at Stapleton Airport, but there was also some of the more classical keyway distress without apparent concrete deterioration shown in the other areas (Figure A-14).

Figure A-14. Longitudinal Joint Distress Between Transverse Joints, Stapleton Airport.

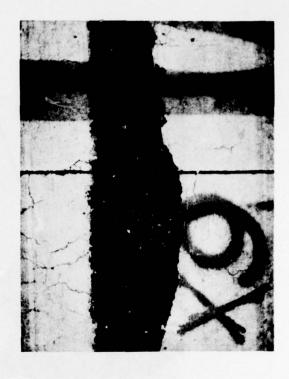
Figure A-18. Photographs Showing the Progressive Deterioration of Concrete Near a Joint-Stapleton Airport.

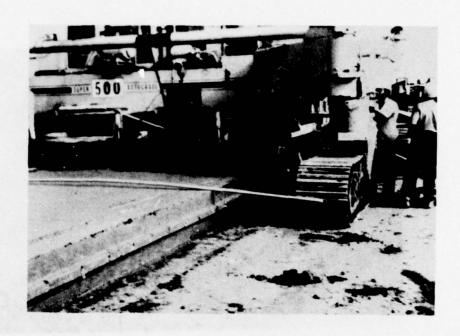
Figure A-22. View of Finished Keyway with First-Half of the Wiggle Bolts in Place, Detroit.

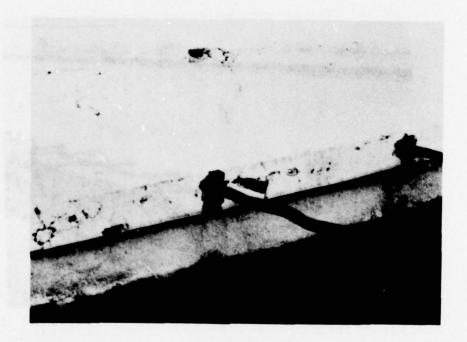
Figure A-23. View of Keyway with Second-Half of Wiggle Bolt in Place, Detroit.

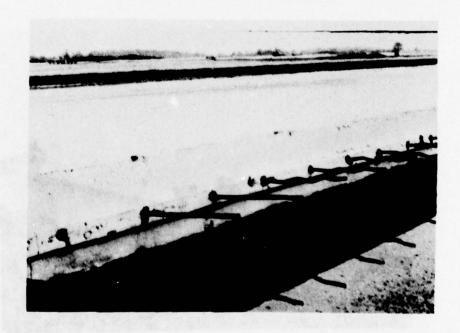
Figure A-25. View of Keyway and Wiggle Bolts in Place with Missing Bolt, Detroit.

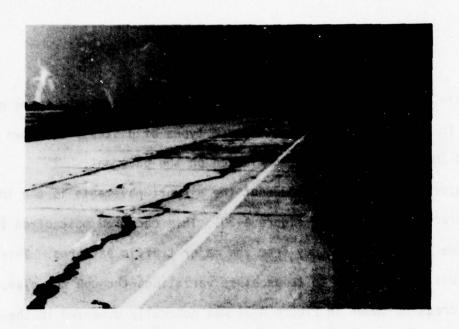
Figure A-30 - Longitudinal Cracking, Kansas City.

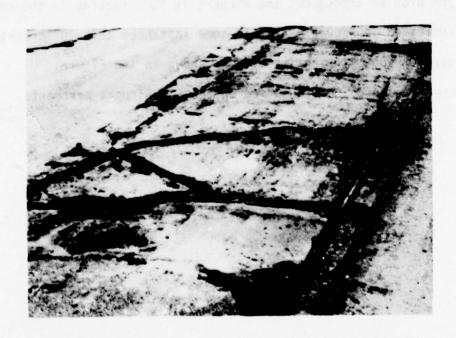
Figure A-31 - General Pavement Failure - Kansas City

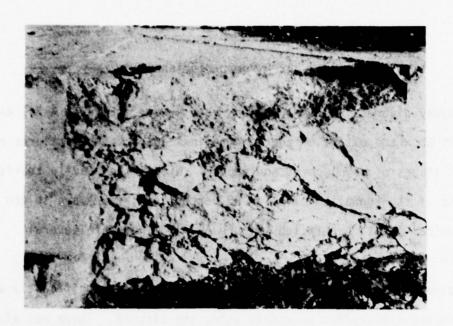
A major problem throughout the airport is "D" cracking in the concrete as indicated in Figure A-32. In some instances this "D" cracking has progressed through the entire slab as shown in the Figure.

Figure A-32 - Failure of Concrete due "D" Cracking. Note the Deterioration has Destroyed the Concrete Completely Through the Slab, Kansas City Airport (Wall).

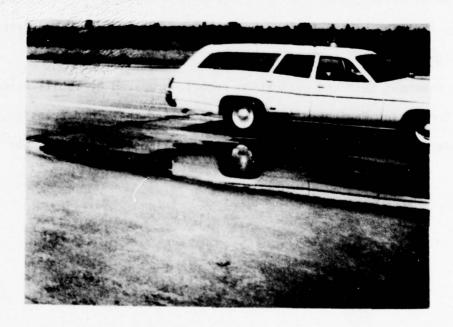
Figure A-33 - Surface Drainage Caused by Non Uniform Settlement of Pavement Slabs.

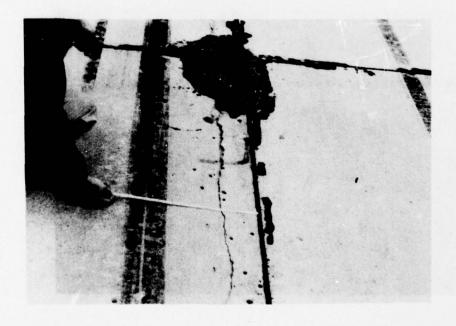
Figure A-35 - Longitudinal Keyed Joint Distress, Indianapolis.

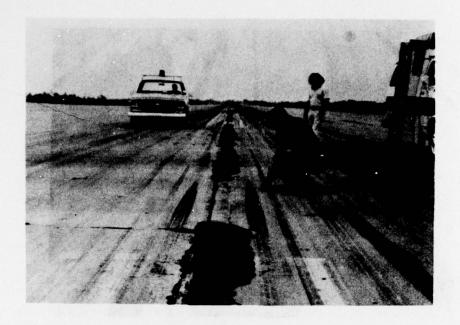
Figure A-36 - Longitudinal Keyed Joint Distress and Repair, Indianapolis.

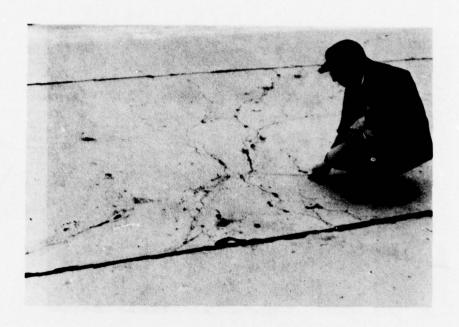
Figure A-38 - Concrete Deterioration, Indianapolis.

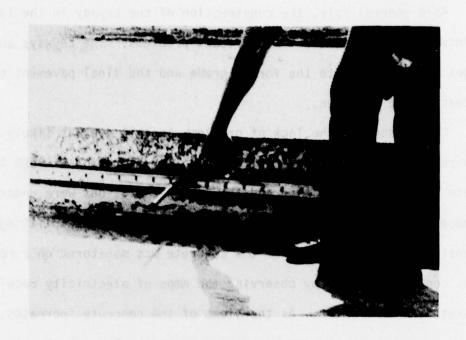
Figure A-47. Keyed Longitudinal Joint with Gap between Metal Insert and Top of Keyway, Wichita.

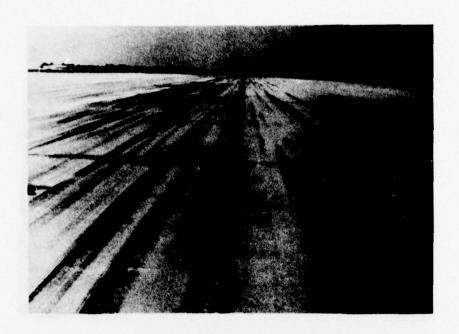
In addition to the construction operations a number of types of pavement distress was also observed. Figures A-49 and A-50 show several cases of longitudinal joint distress. Only Figure A-51 shows a true keyway failure pattern, while the remaining distress was more likely due to construction problems along the edge. "D" cracking as shown in Figure A-52 and A-53 is a problem throughout the airport on all pavements over 5 to 8 years of age. This "D" cracking deterioration has apparently not resulted in any significant increase in keyway failures as suggested for some other airports visited.

Figure A-49 - Longitudinal Joint Distress Repair, Wichita.

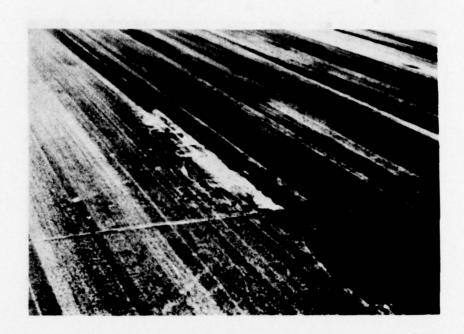
Figure A-51 - Longitudinal Distress of Keyed Joint, Wichita.

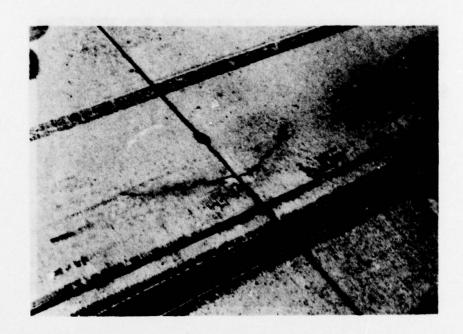
Figure A-52 - "D" Cracking Distress With Restraint Cracking, (Wichita).
